## Fractured Metallic Tracheostomy Tube: Report of a Fractographic Study

**Objective:** To investigate the cause of a broken metallic tracheostomy tube.

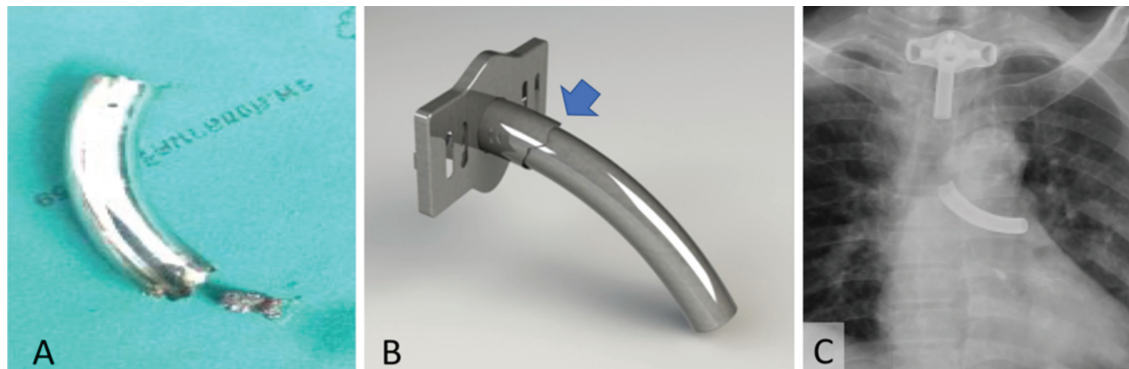
**Figure 1** (A) Macroscopic picture of the distal part of the outer tube retrieved from the bronchus; (B) picture of a new fractured tracheostomy indicating the fracture site (arrow); (C) chest x-ray showing the site of the dislodged outer tube in the left main bronchus.

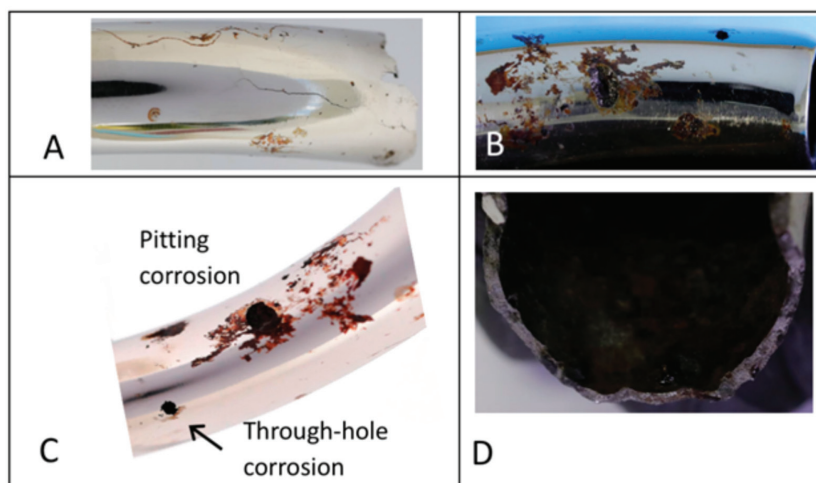
The fractured part of the tracheostomy tube was about 11.5 mm outer diameter (OD), 0.6 mm thick and 55 mm long. It was curved with a polished surface. After cleaning by immersion in absolute alcohol and soft brushing, the surface was seen to be stained with hard brown deposits. Two cracks could be seen, one 22 mm in length longitudinally with branching tips on the outer curve and the second 12 mm in length parallel to the larger one (Figure 2A). There was a corroded pit of about 4x2.5 mm in area and 0.5 mm in depth near the inner curvature (Figure 2B), with a hole right through the tube of 1 mm in diameter (Figure 2C), apparently originating from the internal surface as the external surface was otherwise uncorroded in this area. The fracture was a brittle type as there were no gross deformities or uneven edges. There was thick brown staining on the inner surface of the device (Figure 2D).

**Figure 2** (A) Multiple longitudinal cracks and deposits on the external surface. (B) Pitting corrosion with deposits on the external surface. (C) A full-thickness corrosion hole on the outer curvature. (D) Brittle fracture with no deformation of the tube

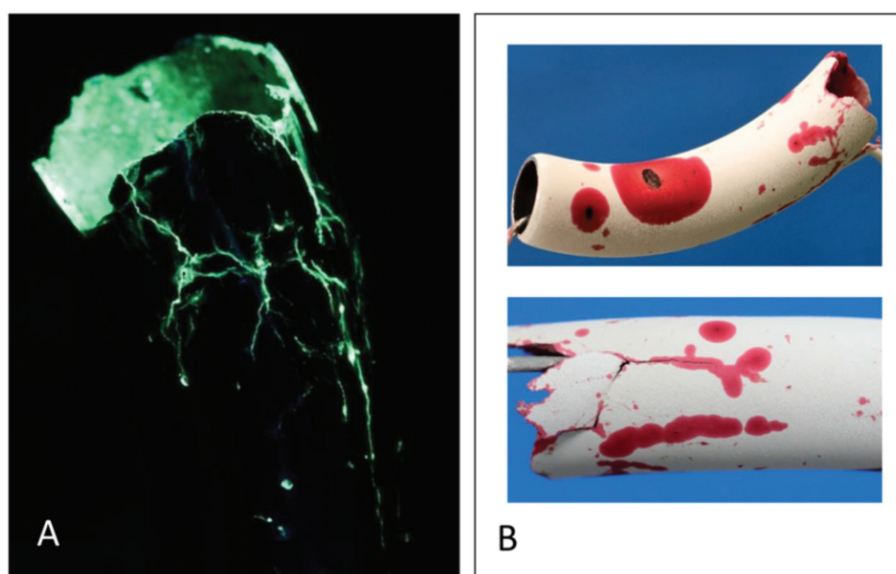
By the application of both a fluorescent liquid penetrant and visible dye penetrant, discrete longitudinal

linear indications of cracking were found clustered close to the fracture site (Figure 3).

**Figure 3** Picture from the liquid penetrant test and fluorescent dye penetrant test at the external surface. (A) With the fluorescent dye penetrant at the external surface, several longitudinal linear cracks were detected around the fracture. (B) With the liquid penetrant test; visible dye penetrant, at the external surface, several linear and round markings were detected.

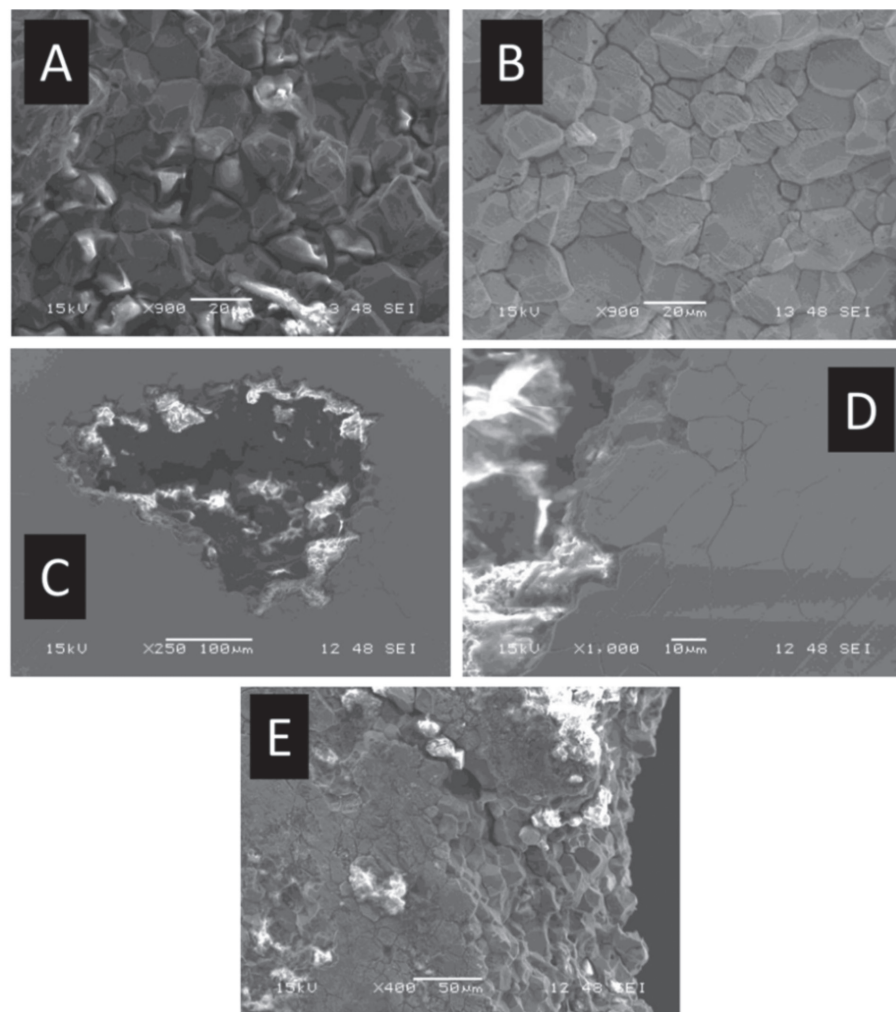
Investigation by SEM showed intergranular corrosion along the fracture site. Cracks could be seen along the grain boundary (Figure 4).

**Figure 4** (A–B) Scanning electron microscopy (SEM) images showing the intergranular corrosion effects at the fracture surface. (C–D) SEM images of the external surface near the pit with intergranular attack. (E) The internal surface close to the fracture also shows inter-granular corrosion effects.

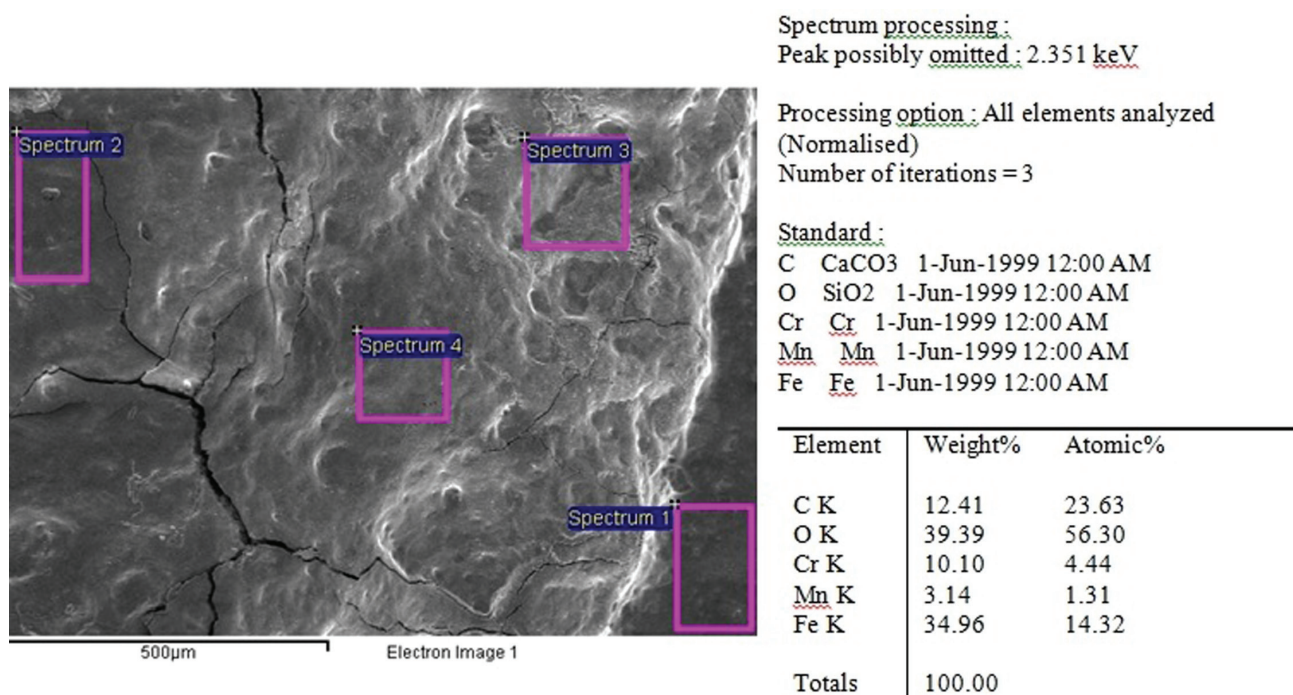
Chemical composition analysis of deposits from the inner surface using EDX Spectroscopy method indicated that the deposits were a ferrous-rich oxide. There were also significant amounts of carbon, manganese, phosphorus and calcium (Figure 5).

**Figure 5** Energy dispersive X-ray spectroscopy report of deposits from the inner surface

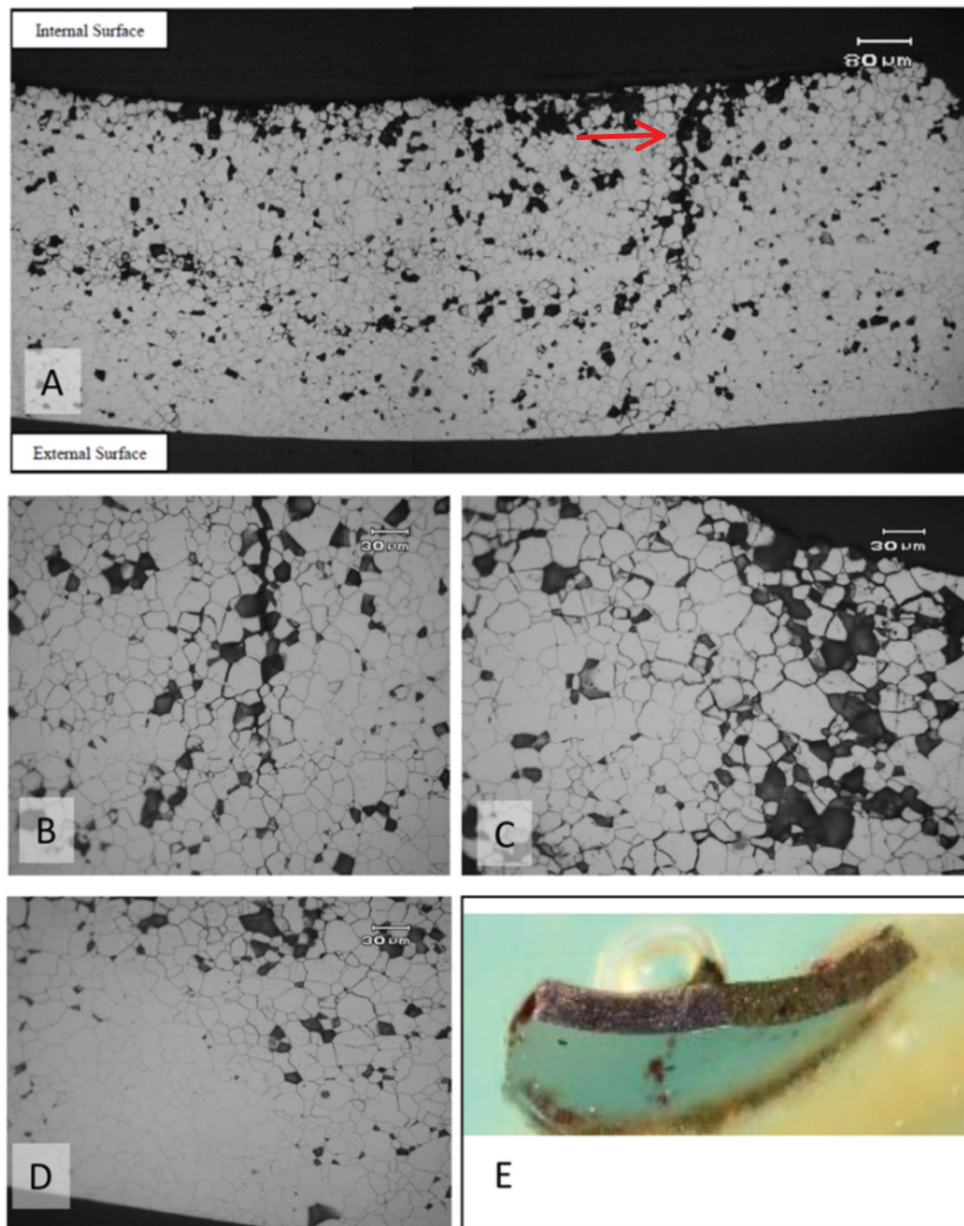
steel, with a significant carbide and/or second phase precipitated intergranular structure in the tube. The cracks appeared to originate at the internal surface in an inter-

granular pattern. Intergranular corrosion was observed in several tested areas with selective grain loss.

**Figure 6** Micrographic pictures of the tube: (A) crack propagation along the internal surface (arrow), (B) intergranular corrosion at the external surface and, (C) the internal surface, (D) carbide and/or second phase precipitation at the grain boundary, (E) the fracture surface of the retrieved fragment.

**Conclusion:** The evidence suggests that the corrosion resistance properties of this material might not be suitable for long term use in the human trachea. Higher grade stainless steel or more frequent device change is recommended.
